**Flood Control Project Maintenance  
Levee Inspections**

**2014 Channel Summary Report**

**Madera County FCWCA**

**Levee Inspection Report By Mile - Channel 2014**

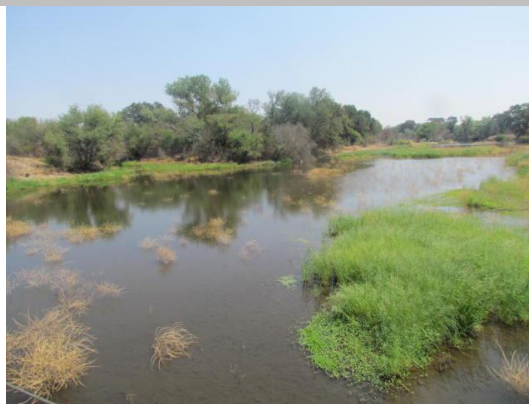
Photo 1 of 1 : CH\_2014\_NA0011\_38\_92\_20140814\_00021.jpg

Rating **	A	Issue No.	92	GPS Lat/Long
Issue Type +	Ma	Location *		37.157888 °
Category	Rivers, Channels & Designated Flood			-120.124010 °
Item	Vegetation & Obstructions			
DWR ID	DWR_NA0011_38_c_2012_92			
Action/Comments				
Inspector Comments: No vegetation or obstructions present to impede flow.

Looking east upstream at channel from low water crossing.

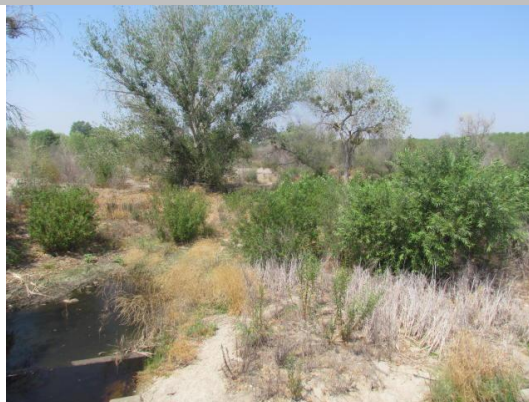
Photo 1 of 1 : CH\_2014\_NA0011\_38\_91\_20140814\_00022.jpg

Looking west (downstream) at channel from low water crossing.

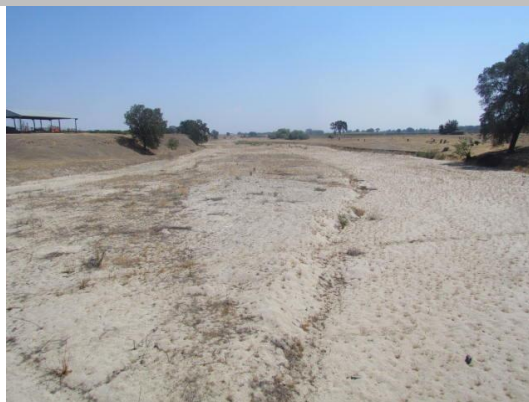
Photo 1 of 1 : CH\_2014\_NA0011\_38\_11\_20140814\_00023.jpg

Looking east (upstream) at channel from Santa Fe Dr.

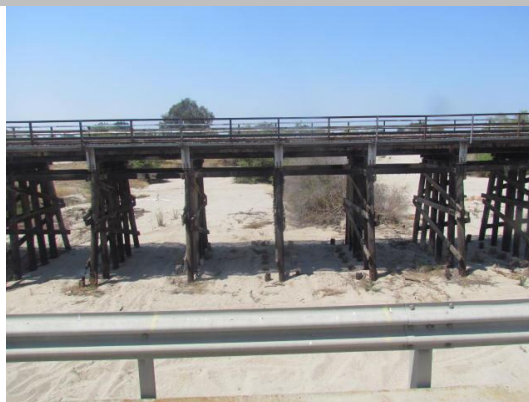
Photo 1 of 1 : CH\_2014\_NA0011\_38\_16\_20140814\_00024.jpg

Looking west (downstream) at channel from Santa Fe Dr.

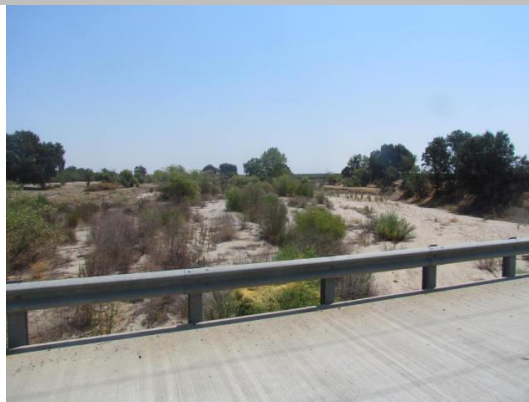
Photo 1 of 1 : CH\_2014\_NA0011\_38\_21\_20140814\_00025.jpg

Looking east (upstream) at channel from Rd. 19.

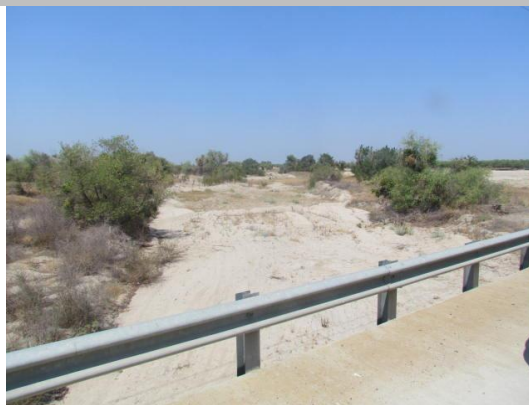
Photo 1 of 1 : CH\_2014\_NA0011\_38\_26\_20140814\_00026.jpg

Looking west (downstream) at channel from Rd. 19.

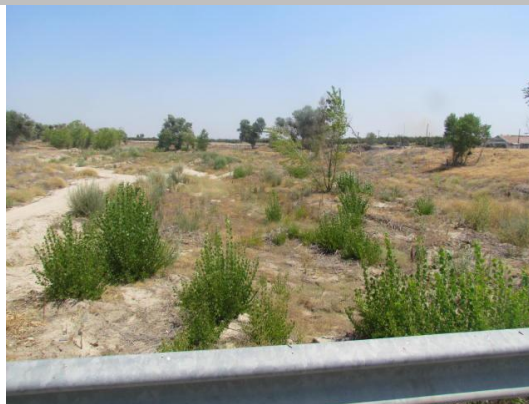
Photo 1 of 1 : CH\_2014\_NA0011\_38\_31\_20140818\_00027.jpg

Looking east (upstream) at channel from Road 13.

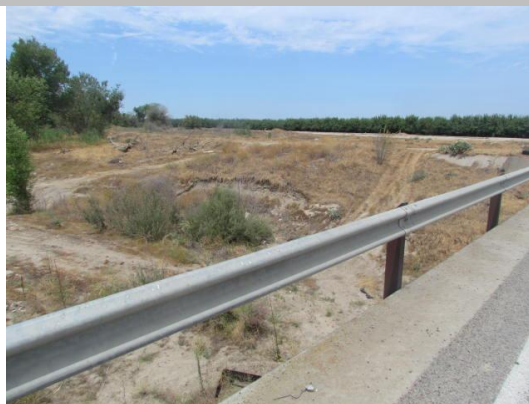
Photo 1 of 1 : CH\_2014\_NA0011\_38\_29\_20140710\_00007.jpg

Looking southwest at small erosion in channel from Road 13.

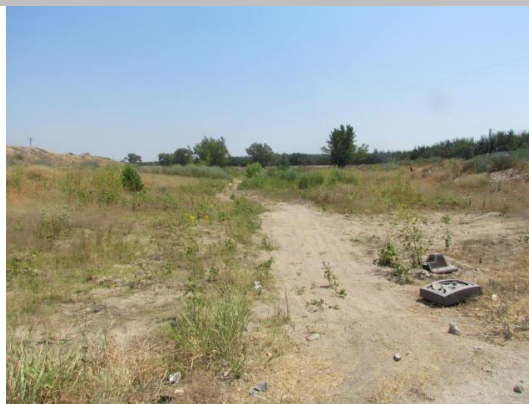
Photo 1 of 1 : CH\_2014\_NA0011\_38\_51\_20140818\_00028.jpg

Looking east (upstream) at channel from Road 12.

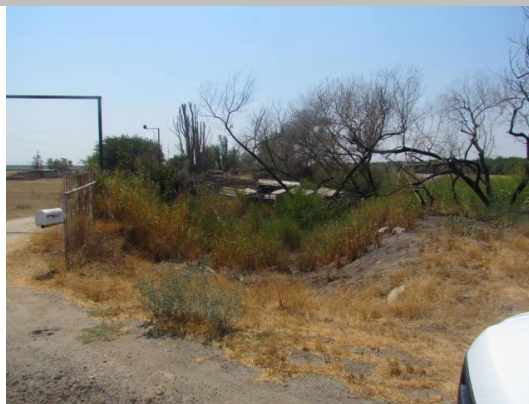
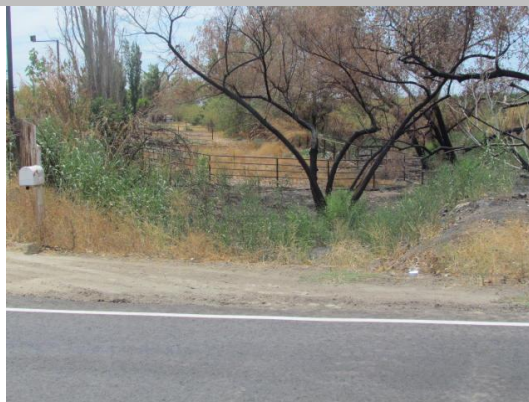
Photo 1 of 2 : CH\_2014\_NA0011\_38\_90\_20140818\_00035.jpg

Looking west at animal pen with animal cages in channel from Road 9. (2014)

Looking west at animal pen in channel from Road 9. (2013)

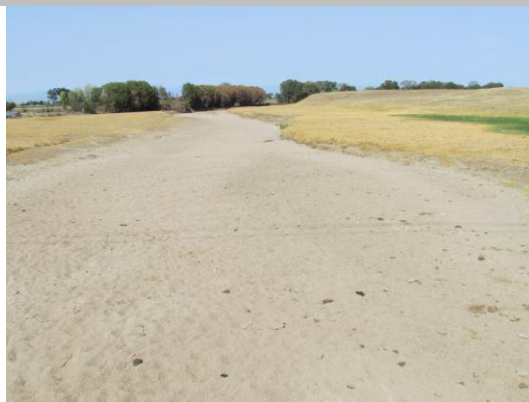
Photo 1 of 1 : CH\_2014\_NA0011\_39\_1\_20140815\_00031.jpg

Berenda Slough looking upstream from Santa Fe Drive crossing the channel. No vegetation and no water at this location.

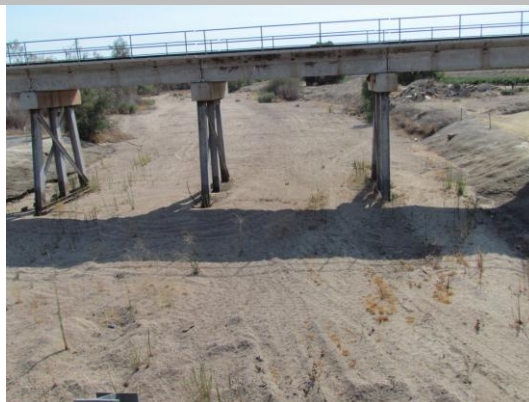
Photo 1 of 1 : CH\_2014\_NA0011\_39\_6\_20140815\_00032.jpg

Berenda Slough looking downstream from Santa Fe Drive. Open channel no vegetation and no water at location.

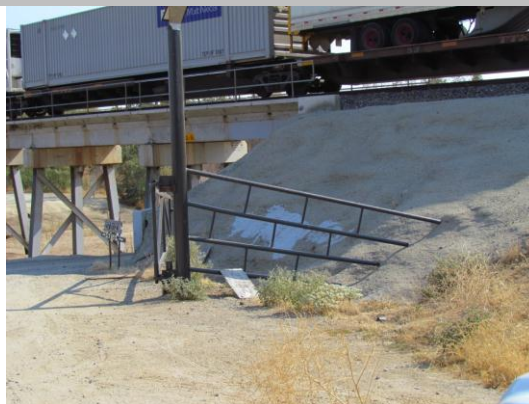
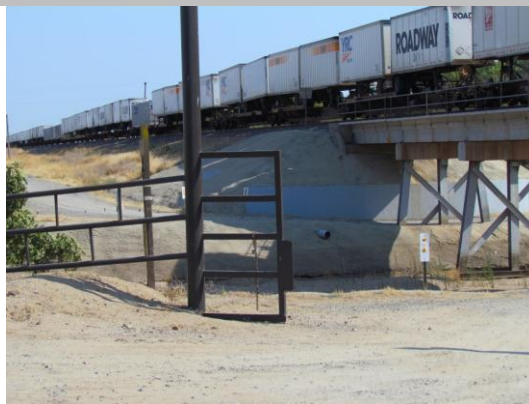
Photo 1 of 2 : CH\_2014\_NA0011\_39\_10\_20140804\_00026.jpg

Land owner has installed a new gate on right bank of the Berenda Slough downstream of bridge crossing.

Another shot of the new gate, no permit on file.

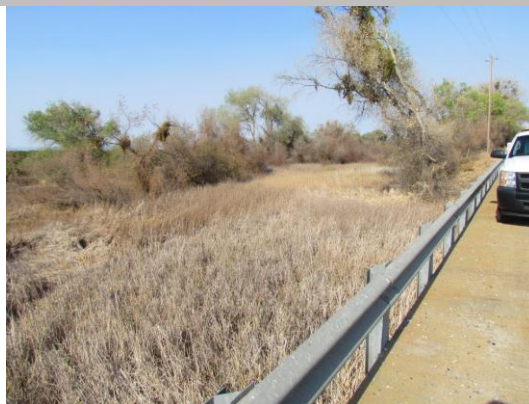
Photo 1 of 1 : CH\_2014\_NA0011\_39\_11\_20140804\_00025.jpg

Berenda Slough looking upstream from 26 Avenue, channel overgrown with tules.

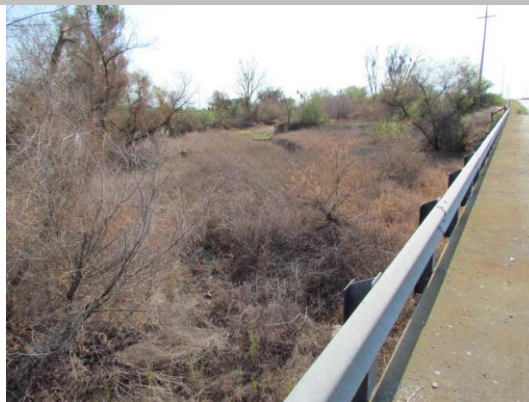
Photo 1 of 1 : CH\_2014\_NA0011\_39\_16\_20140804\_00028.jpg

Berenda Slough looking downstream from Avenue 26 bridge crossing.  
No change since last inspection.

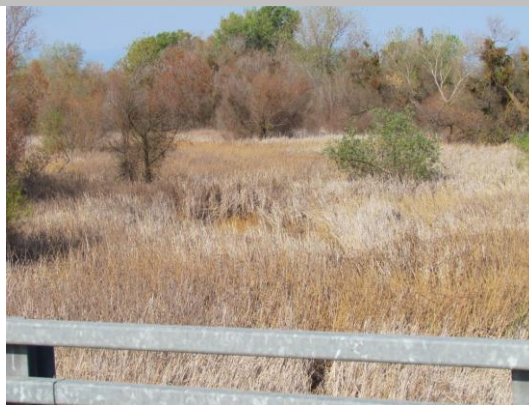
Photo 1 of 1 : CH\_2014\_NA0011\_39\_21\_20140805\_00029.jpg

Berenda Slough looking upstream from Road 19. Channel continue to be overgrown with tulies and other wild growth.

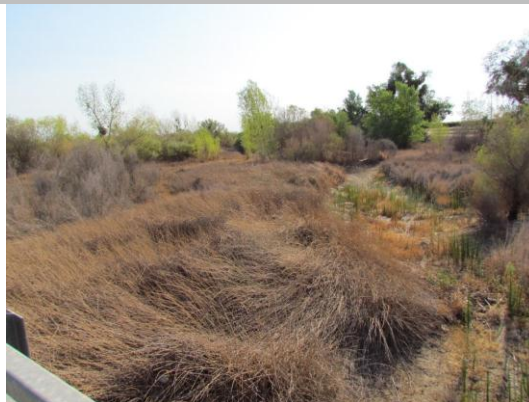
Photo 1 of 1 : CH\_2014\_NA0011\_39\_26\_20140805\_00030.jpg

Berenda Slough looking downstream from Road 19, wild growth of tulies and trees in flood control channel.

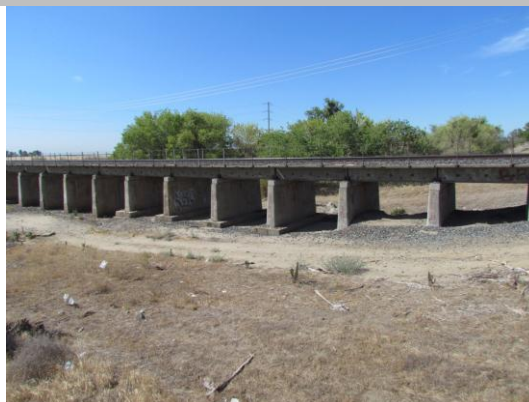
Photo 1 of 1 : CH\_2014\_NA0011\_39\_36\_20140815\_00034.jpg

Berenda Slough looking downstream from Chowchilla Blvd. No water or vegetation in channel at this location.

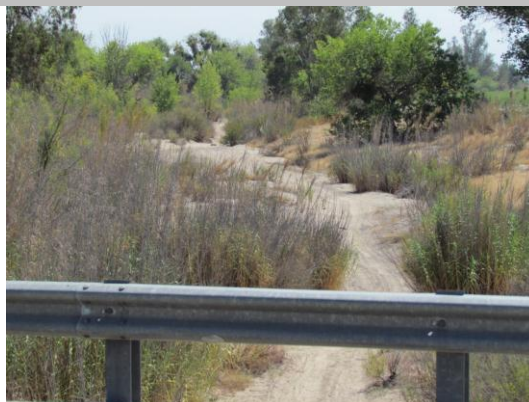
Photo 1 of 1 : CH\_2014\_NA0011\_39\_41\_20140815\_00036.jpg

Berenda Slough looking upstream from Road 16. Wild growth of vegetation in channel.

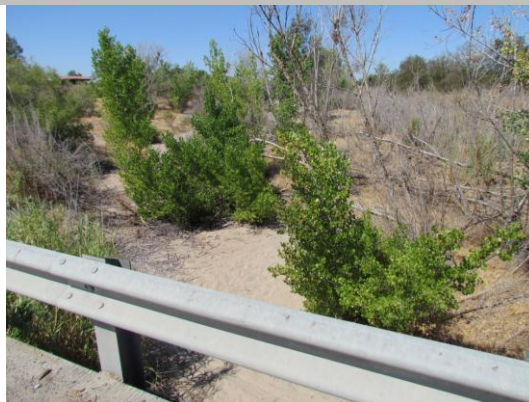
Photo 1 of 1 : CH\_2014\_NA0011\_39\_46\_20140815\_00037.jpg

Berenda Slough looking downstream from Road 16. Trees growing in channel under and near the bridge.

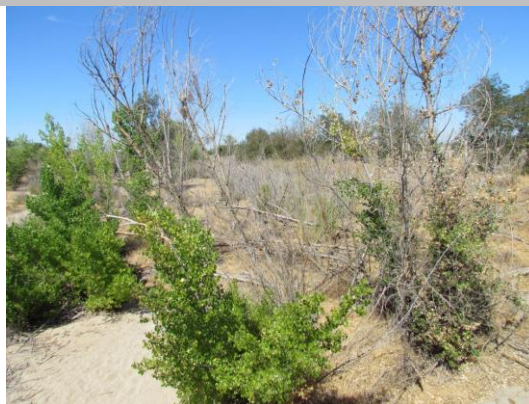
Photo 1 of 1 : CH\_2014\_NA0011\_39\_50\_20140815\_00038.jpg

Looking downstream from the bridge right bank cutup trees in channel.

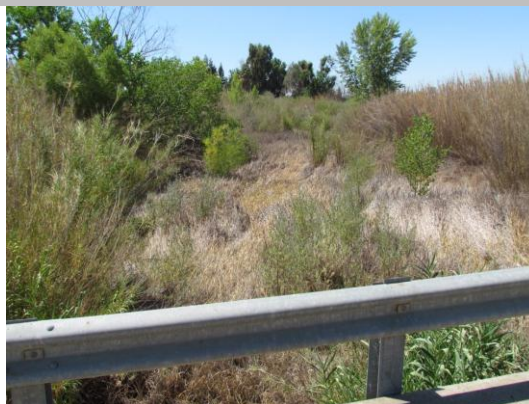
Photo 1 of 1 : CH\_2014\_NA0011\_39\_111\_20140815\_00041.jpg

Berenda Slough looking upstream from Avenue 21 channel and both banks overgrown with wild growth of trees and Arundo.

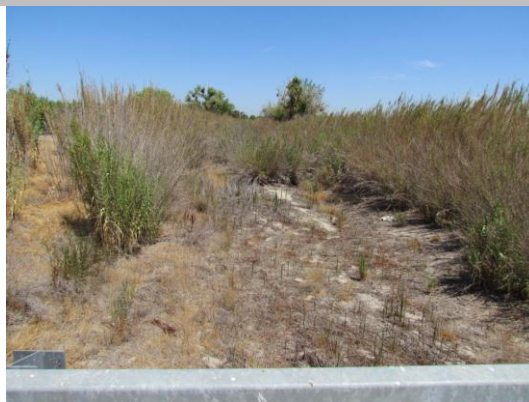
Photo 1 of 1 : CH\_2014\_NA0011\_39\_71\_20140819\_00043.jpg

Looking upstream from Avenue 20 channel overgrown with arundo and other wild growth.

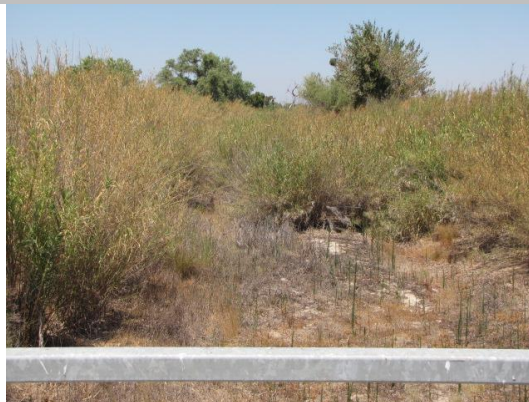
Photo 1 of 1 : CH\_2014\_NA0011\_39\_76\_20140707\_00015.jpg

Berenda Slough looking downstream from Ave.20. Bambo has covered channel and both banks. Photo taken 7-31-2013.

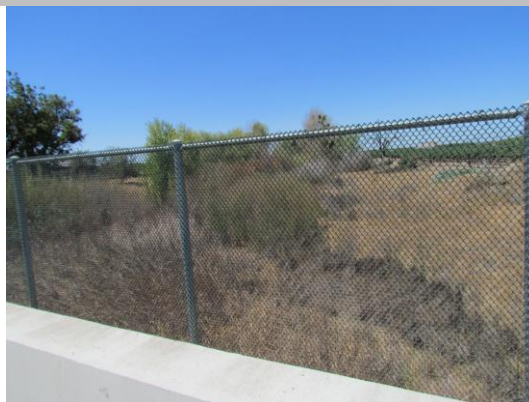
Photo 1 of 1 : CH\_2014\_NA0011\_39\_86\_20140819\_00045.jpg

Berenda Slough from Road 13. Channel covered with wild growth.

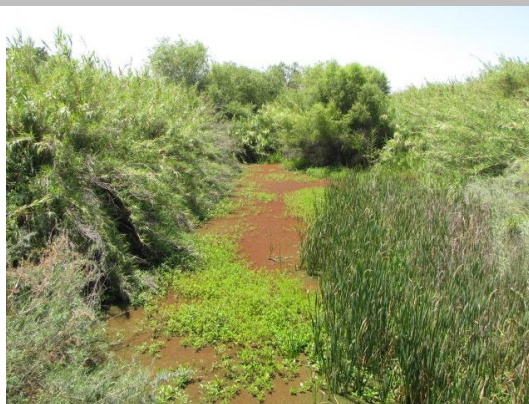
Photo 1 of 1 : CH\_2014\_NA0011\_39\_91\_20140707\_00018.jpg

Berenda Slough looking upstream from Rd. 14 channel and banks overgrown. Photo taken 7-31-2013. No new picture taken of site 2014.

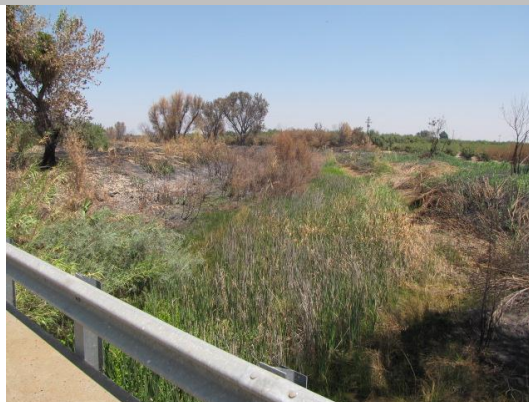
Photo 1 of 1 : CH\_2014\_NA0011\_39\_96\_20140707\_00019.jpg

Berenda Slough at Rd 14 downstream Channel has been burned prior to the inspection. Photo taken 7-31-2013. No new picture taken of site.

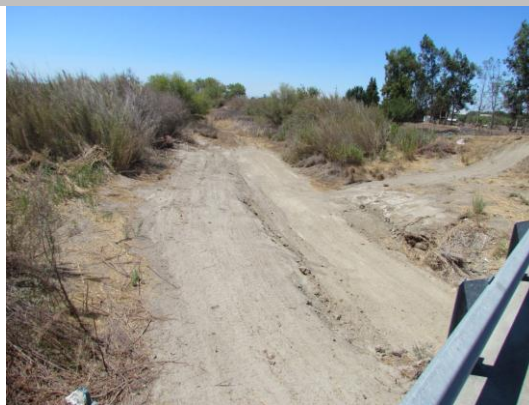
Photo 1 of 1 : CH\_2014\_NA0011\_39\_101\_20140819\_00046.jpg

Berenda Slough looking upstream from Avenue 18 1/2 crossing some channel clearing has been done.

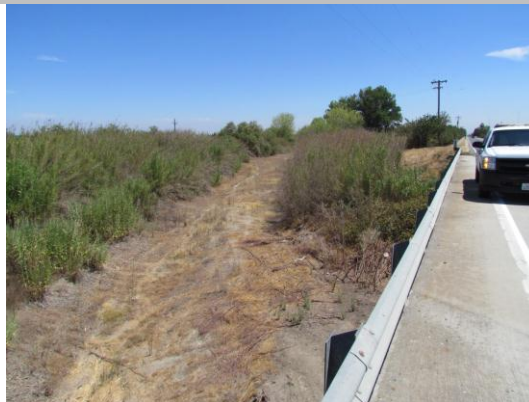
Photo 1 of 1 : CH\_2014\_NA0011\_39\_106\_20140820\_00047.jpg

Berenda Slough looking downstream from Avenue 18 1/2. Wild growth partially removed from pilot channel.

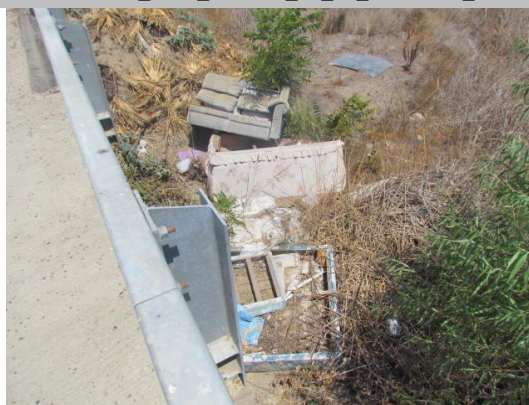
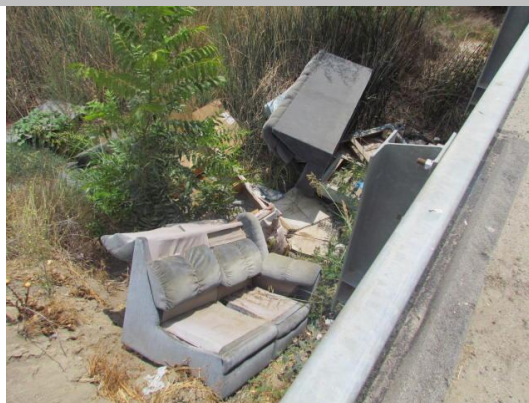
Photo 1 of 2 : CH\_2014\_NA0011\_40\_23\_20140818\_00032.jpg

Looking southeast at trash in channel from Road 13. (2014)

Looking southeast at trash in channel. (2013)

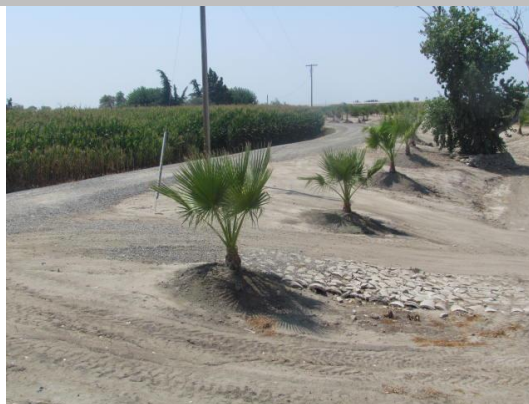
Photo 1 of 1 : CH\_2014\_NA0011\_40\_44\_20140818\_00039.jpg

Looking west (downstream) at palm trees in channel from Road 9.

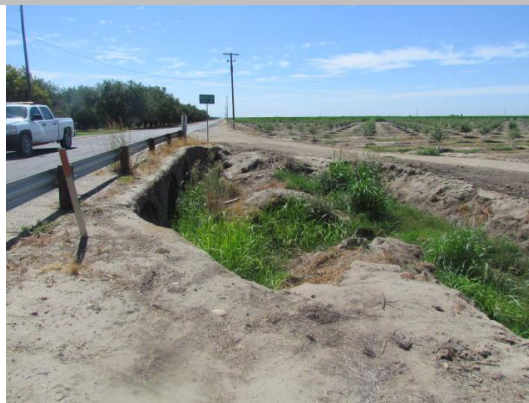
Photo 2 of 2 : CH\_2014\_NA0011\_40\_34\_20140710\_00018.jpg

Looking northwest at sedimentation in channel upstream of Washington Rd.

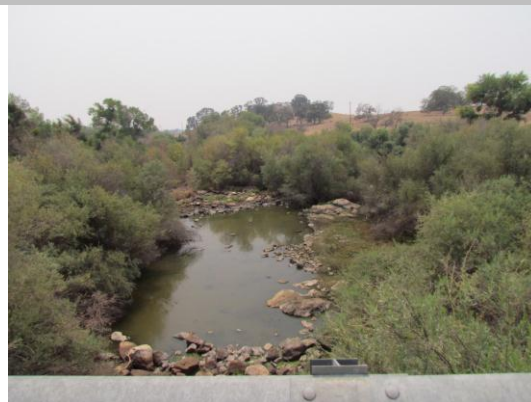
Photo 1 of 1 : CH\_2014\_NA0011\_41\_6\_20140731\_00017.jpg

Fresno River downstream from bridge channel is congested with wild growth on both banks.

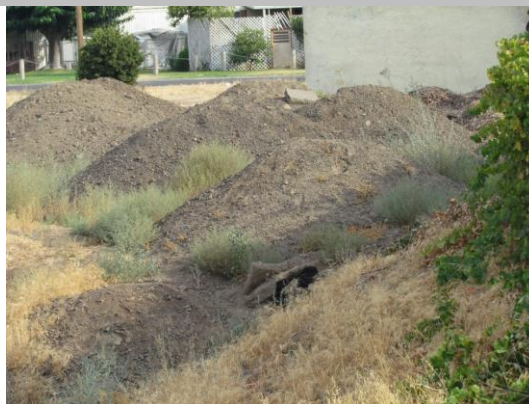
Photo 1 of 1 : CH\_2014\_NA0011\_41\_40\_20140812\_00025.jpg

Dirt piles and concrete dumped on left bank downstream of bridge on the berm.

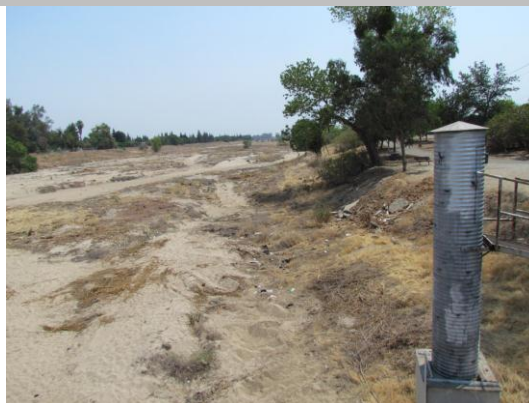
Photo 1 of 1 : CH\_2014\_NA0011\_41\_41\_20140812\_00026.jpg

Fresno River from Granada Avenue crossing looking upstream from bridge, no growth in channel.

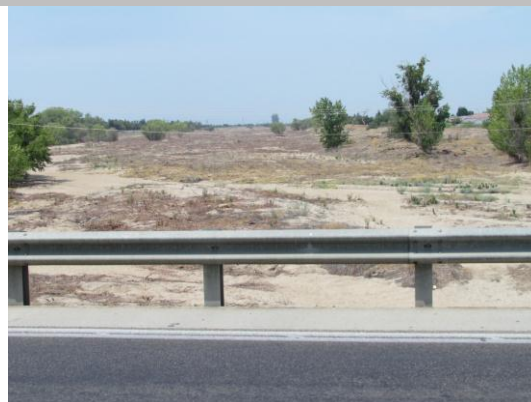
Photo 1 of 1 : CH\_2014\_NA0011\_41\_46\_20140812\_00027.jpg

Fresno River downstream from Granada Avenue Bridge crossing. No vegetation in channel.

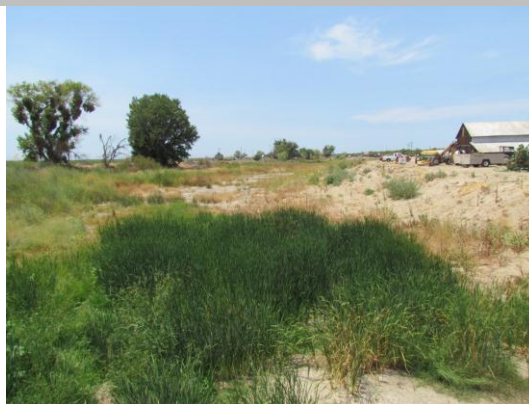
Photo 1 of 1 : CH\_2014\_NA0011\_41\_66\_20140813\_00031.jpg

Fresno River looking downstream from Road crossing, vegetation present in channel.
